# Resistance to Fracture, Fatigue and Stress-Corrosion of Al-Cu-Li-Zr Alloys

A. K. Vasudevan, R. C. Malcolm,  
W. G. Fricke, and R. J. Rioja

Aluminum Company of America  
Alcoa Laboratories  
Alcoa Center, PA 15069

Final Report  
(Period: 1981 July 01 to 1985 February 28)  
Contract N00019-80-C-0569  
Department of the Navy  
Naval Air Systems Command  
Washington, D.C. 20361

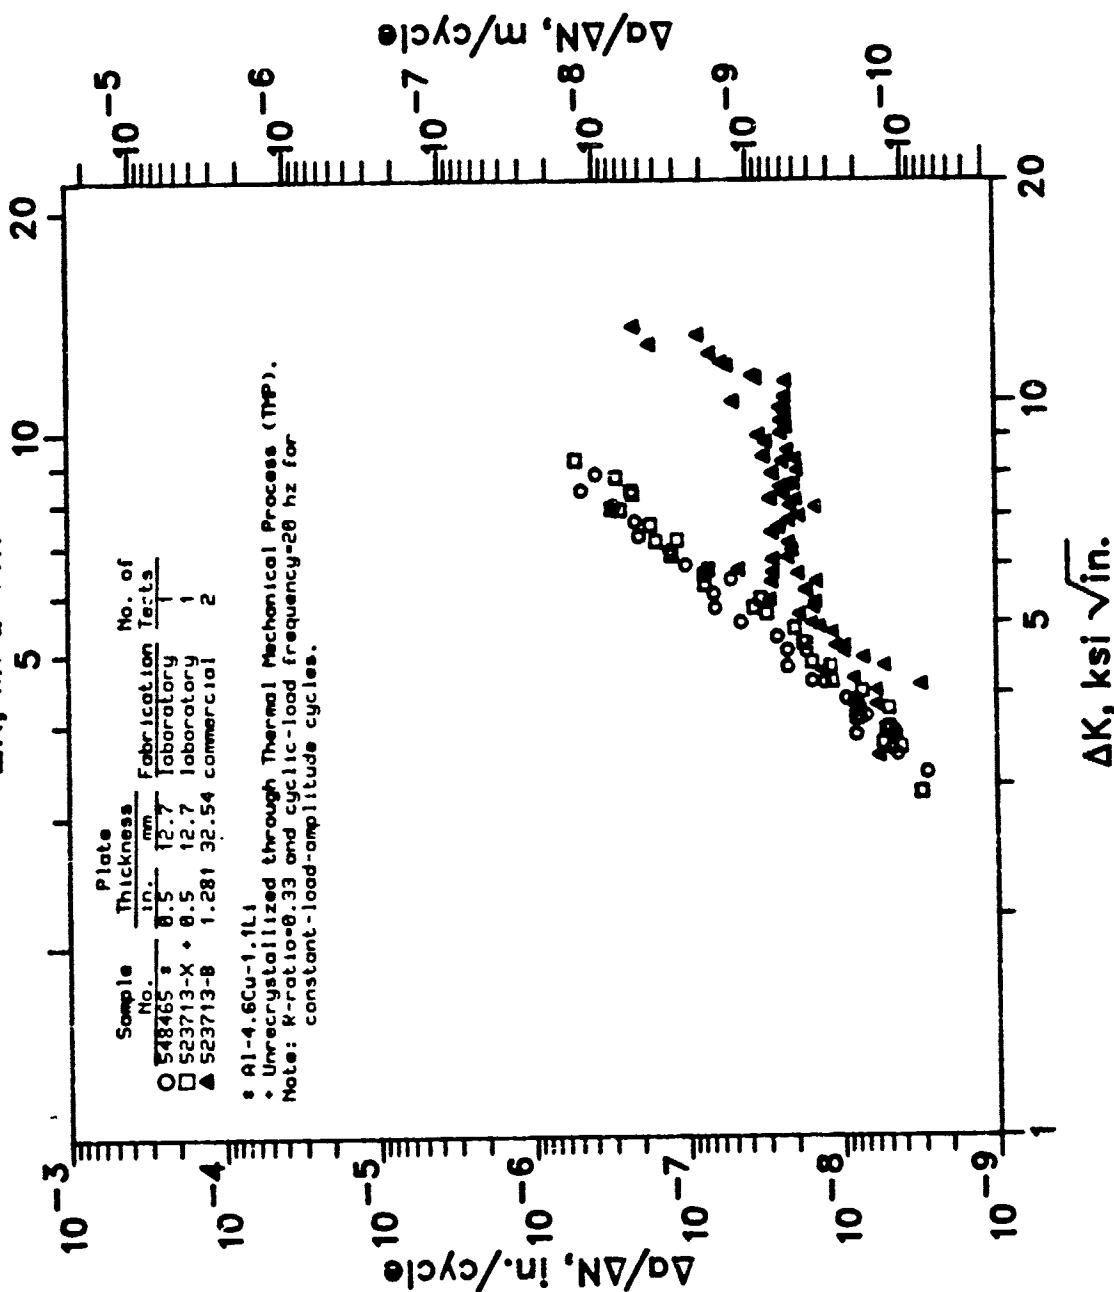
Comparison of Overload Spectrum (OLR=1.8, OCR=1:8000) Fatigue Crack Growth Data for Three Samples of Aluminum Alloy 2020-T651 Plate (two laboratory fabricated and one commercially produced) L-T orientation. high humidity (r.h.>90%) air

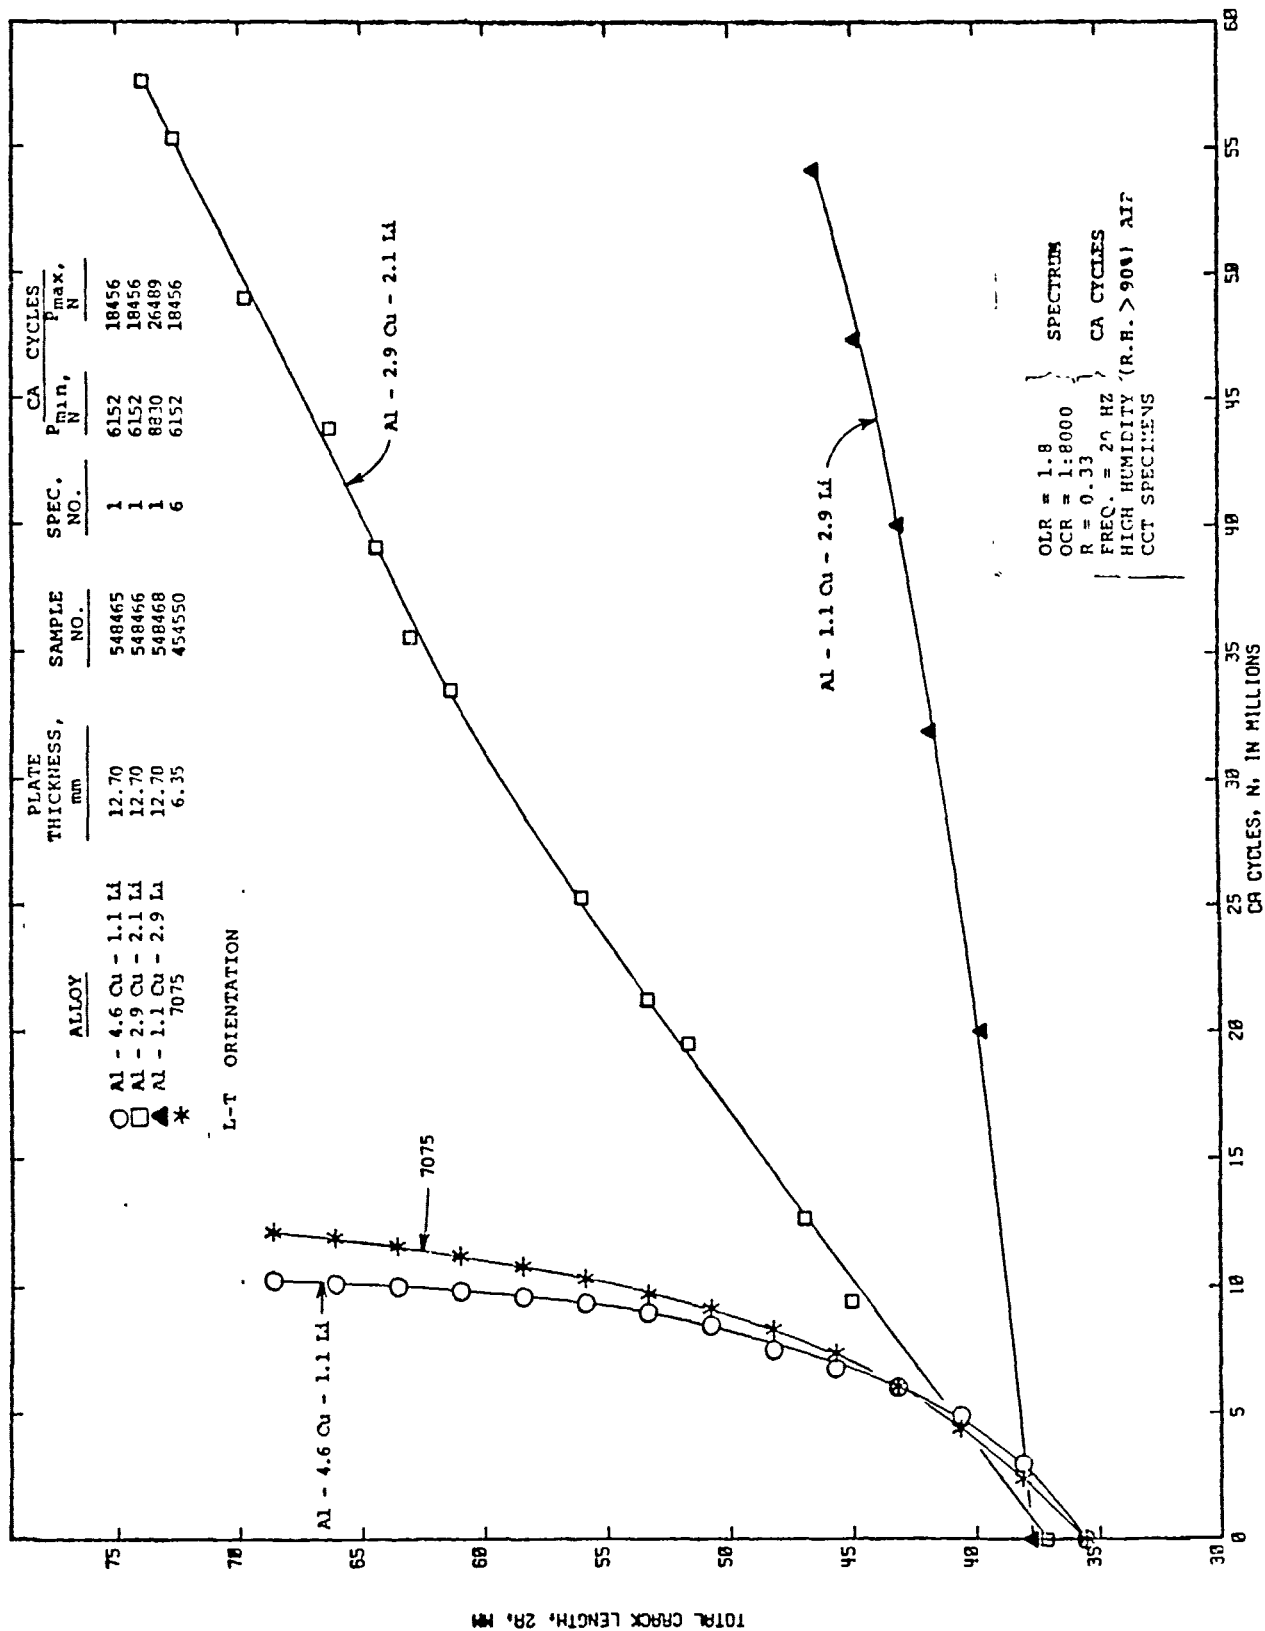
COMPARISON OF TOTAL CRACK LENGTH VERSUS NUMBER OF CA CYCLES DATA OF  
SINGLE PERIODIC OVERLOAD FCC TESTS OF LABORATORY FABRICATED PLATES OF  
THREE (AL - CU - LI) - T651 ALLOYS AND 7075-T651

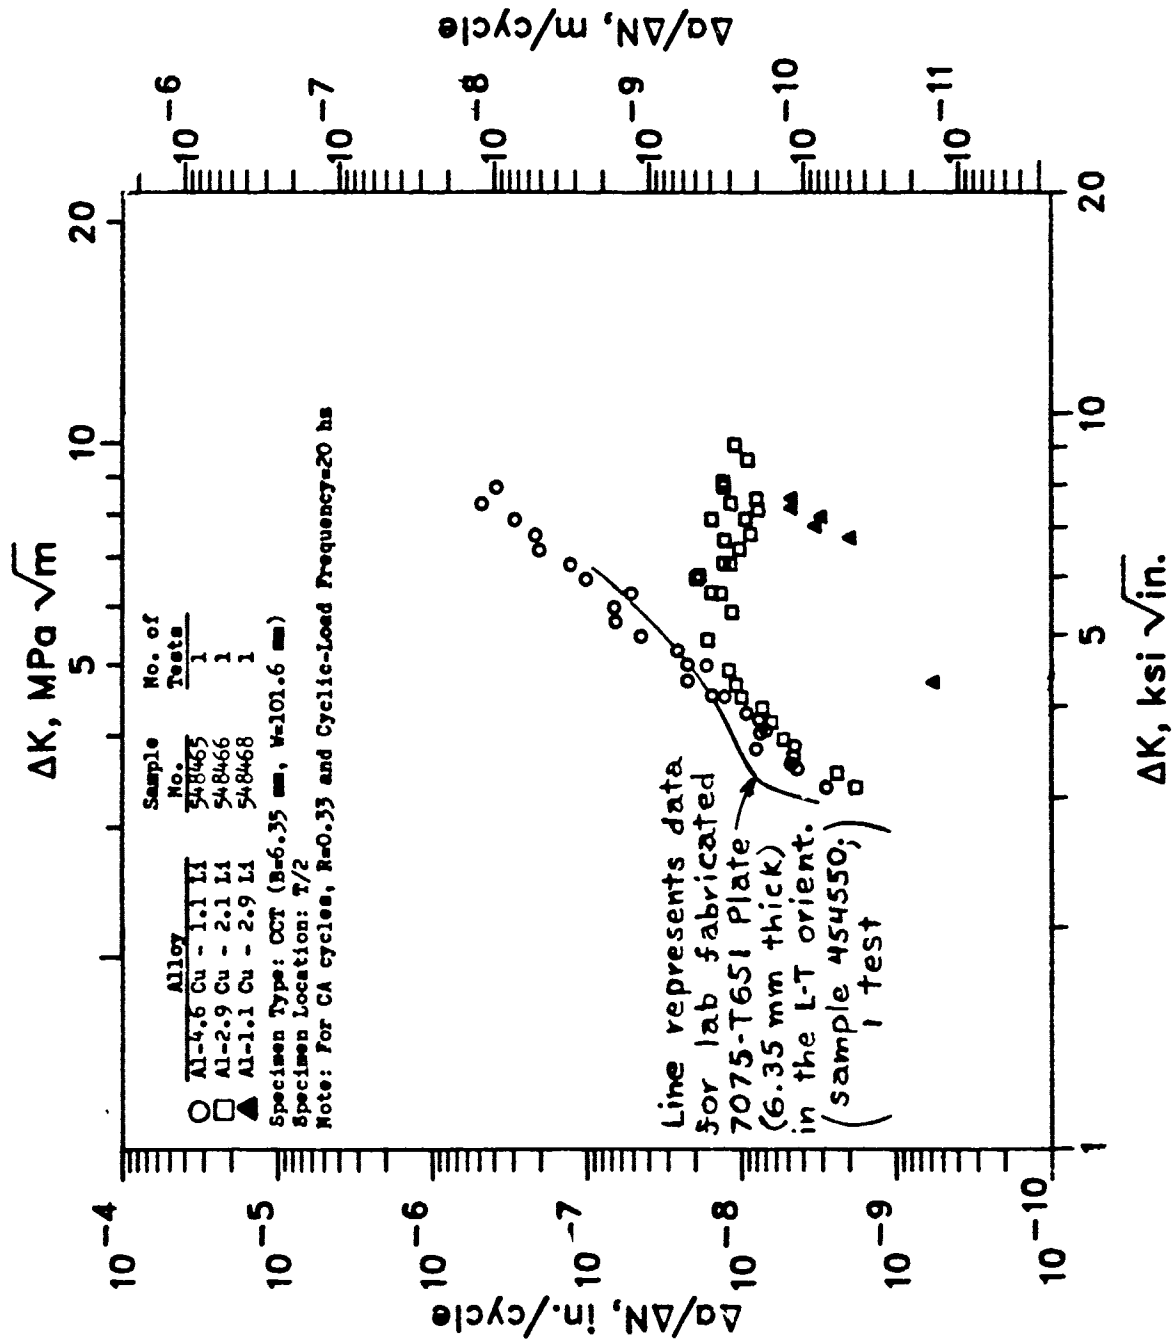
Comparison of Overload Spectrum (OLR = 1.8, OCR = 1:8000)  
 Fatigue Crack Growth Data for Laboratory Fabricated Plates,  
 0.5-in. (12.7 mm) thick, of Three Al-Li Alloys (T651 Temper)  
 L-T orientation. High Humidity (R.H.>90%) Air

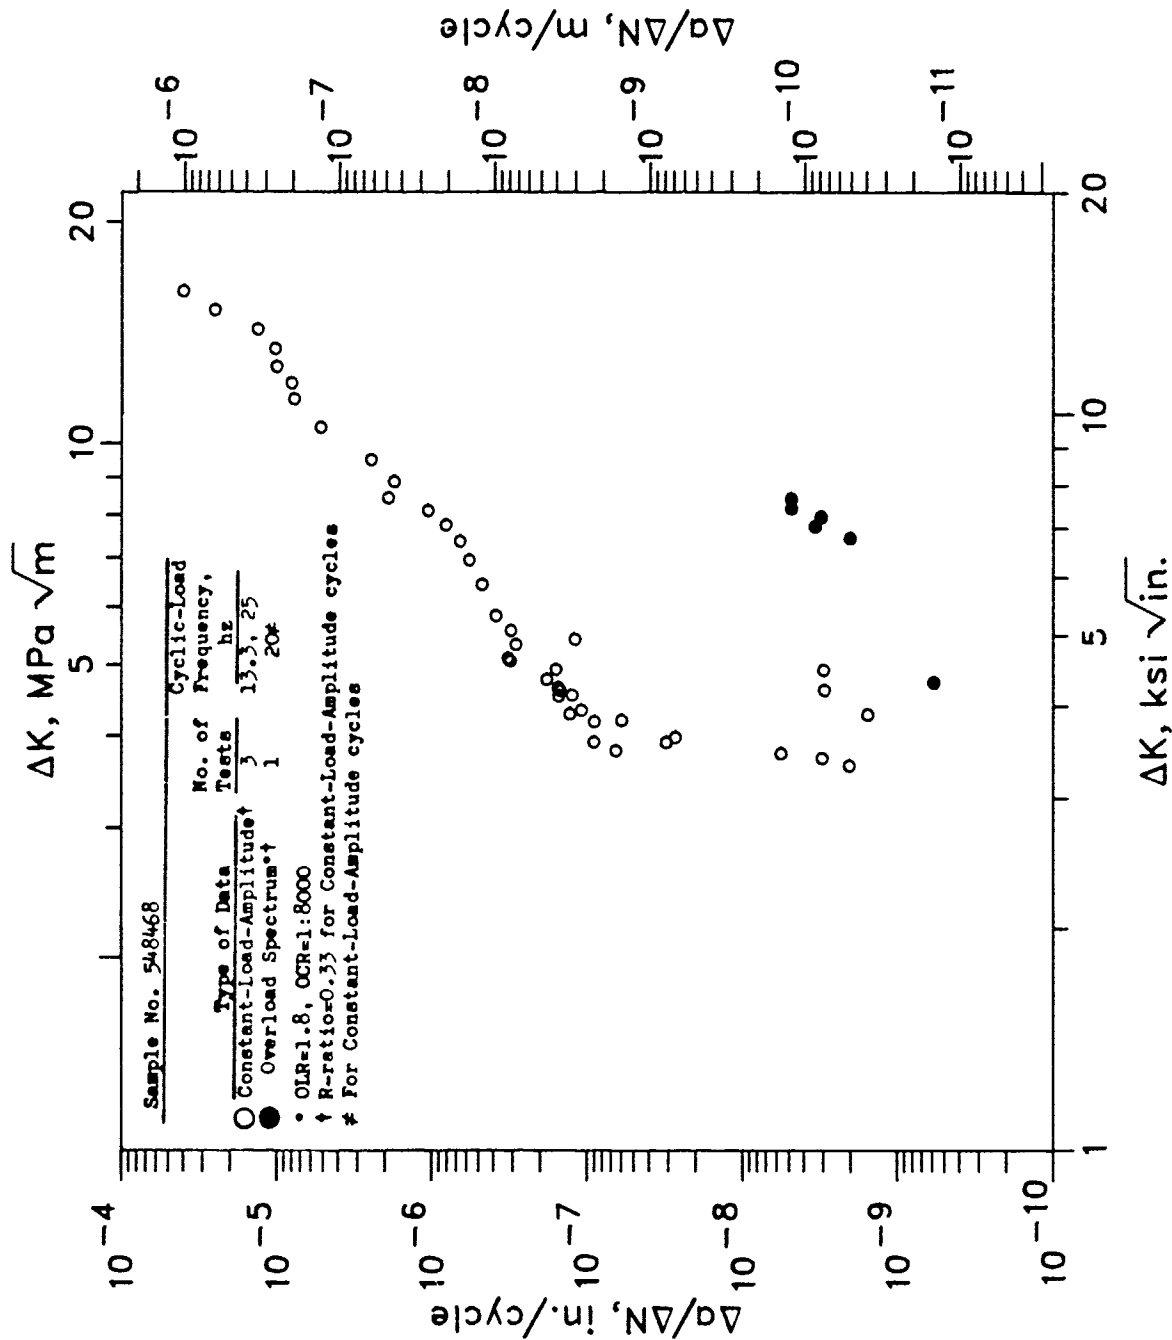
Comparison of Constant-Load-Amplitude and Overload Spectrum Fatigue Crack Growth Data for Laboratory Fabricated Aluminum Alloy (1.1 Cu - 2.9 Li) - T651 Plate, 0.5-in. (12.7mm) thick L-T orientation, High Humidity (R.H.>90%) Air

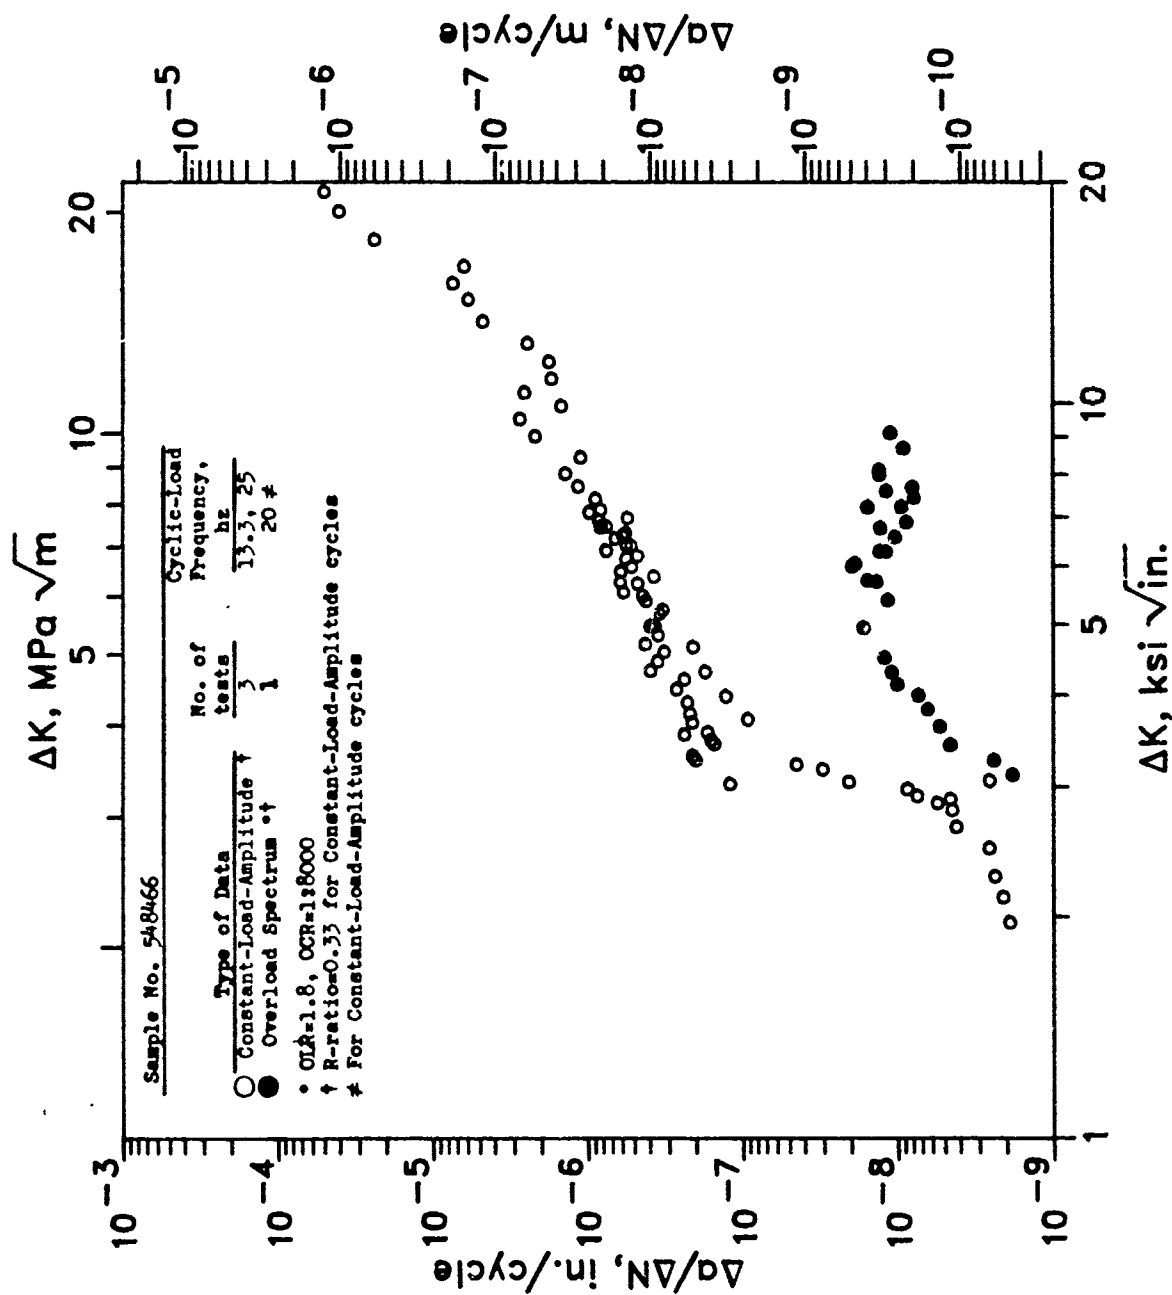
Comparison of Constant-Load-Amplitude and Overload Spectrum Fatigue Crack Growth Data for Laboratory Fabricated Aluminum Alloy (2.9 Cu - 2.1 Li) - T651 Plate, 0.5-in. (12.7 mm) thick  
 1. T orientation, High Humidity (RH > 90%) Air

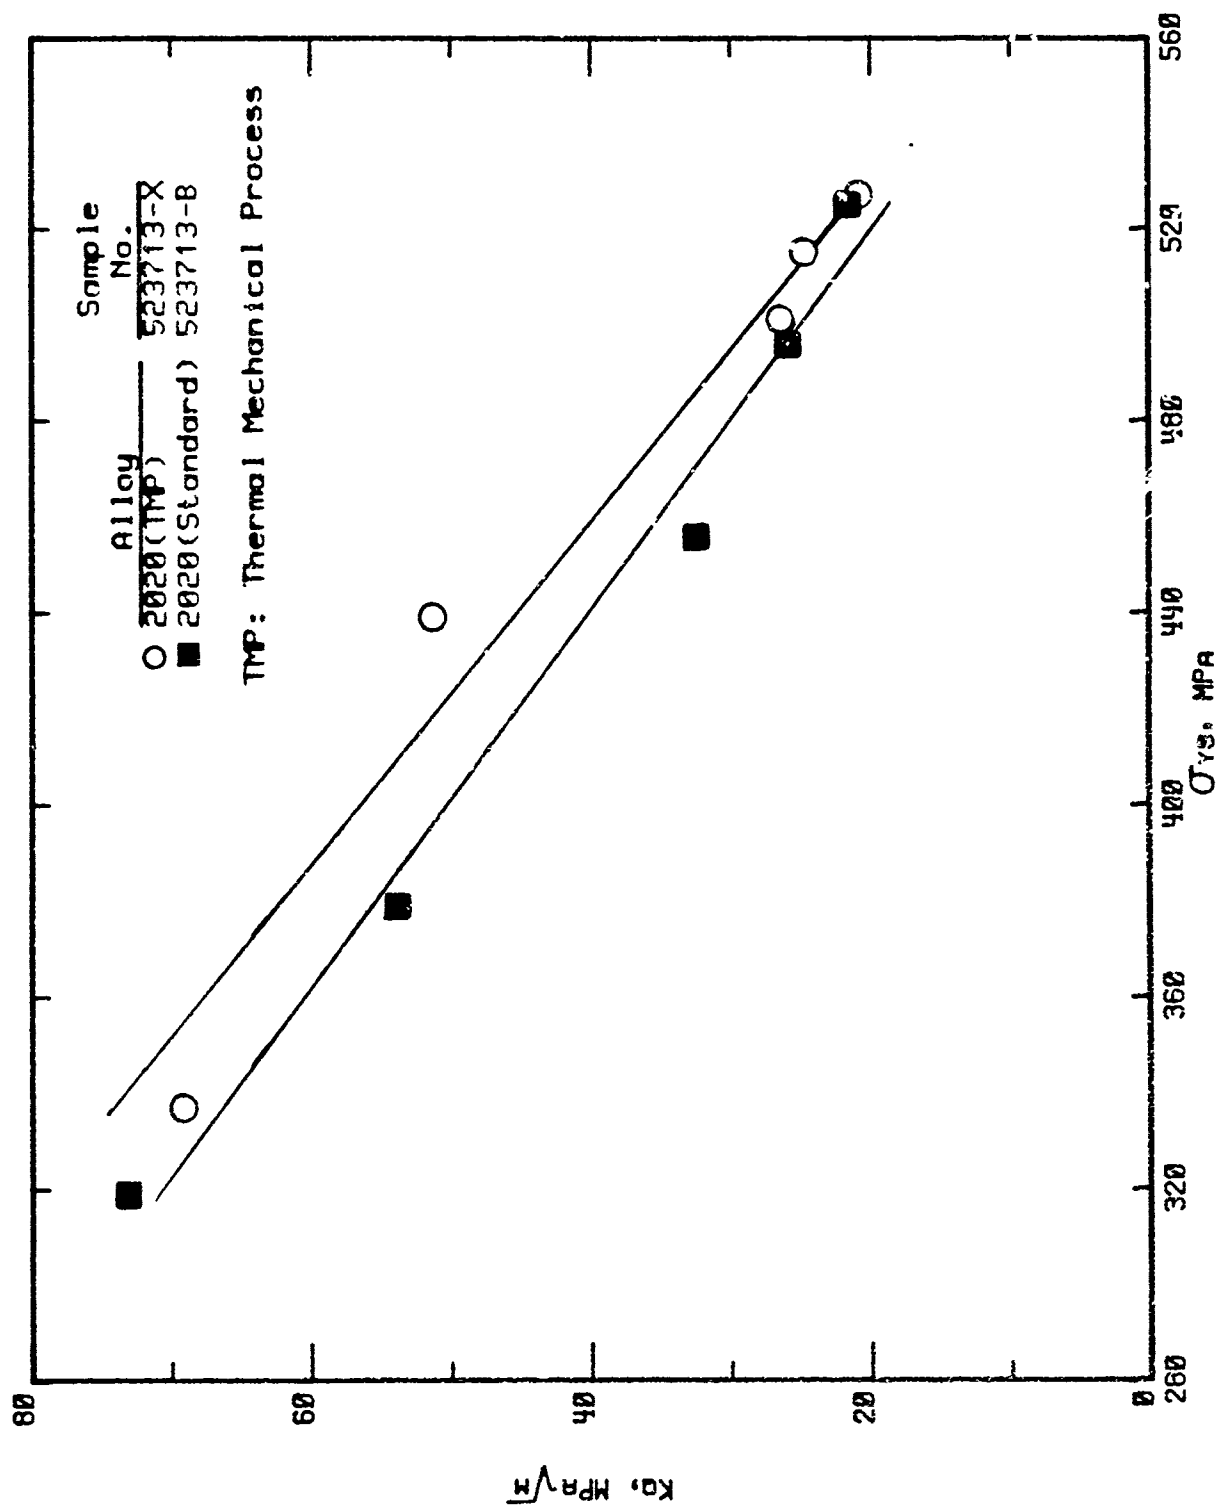
FRACTURE TOUGHNESS ( $K_0$ ) VERSUS TENSILE YIELD STRENGTH ( $\sigma_{ys}$ )  
COMPARISON OF TMP 2020 AND STANDARD 2020 ALUMINUM ALLOYS.

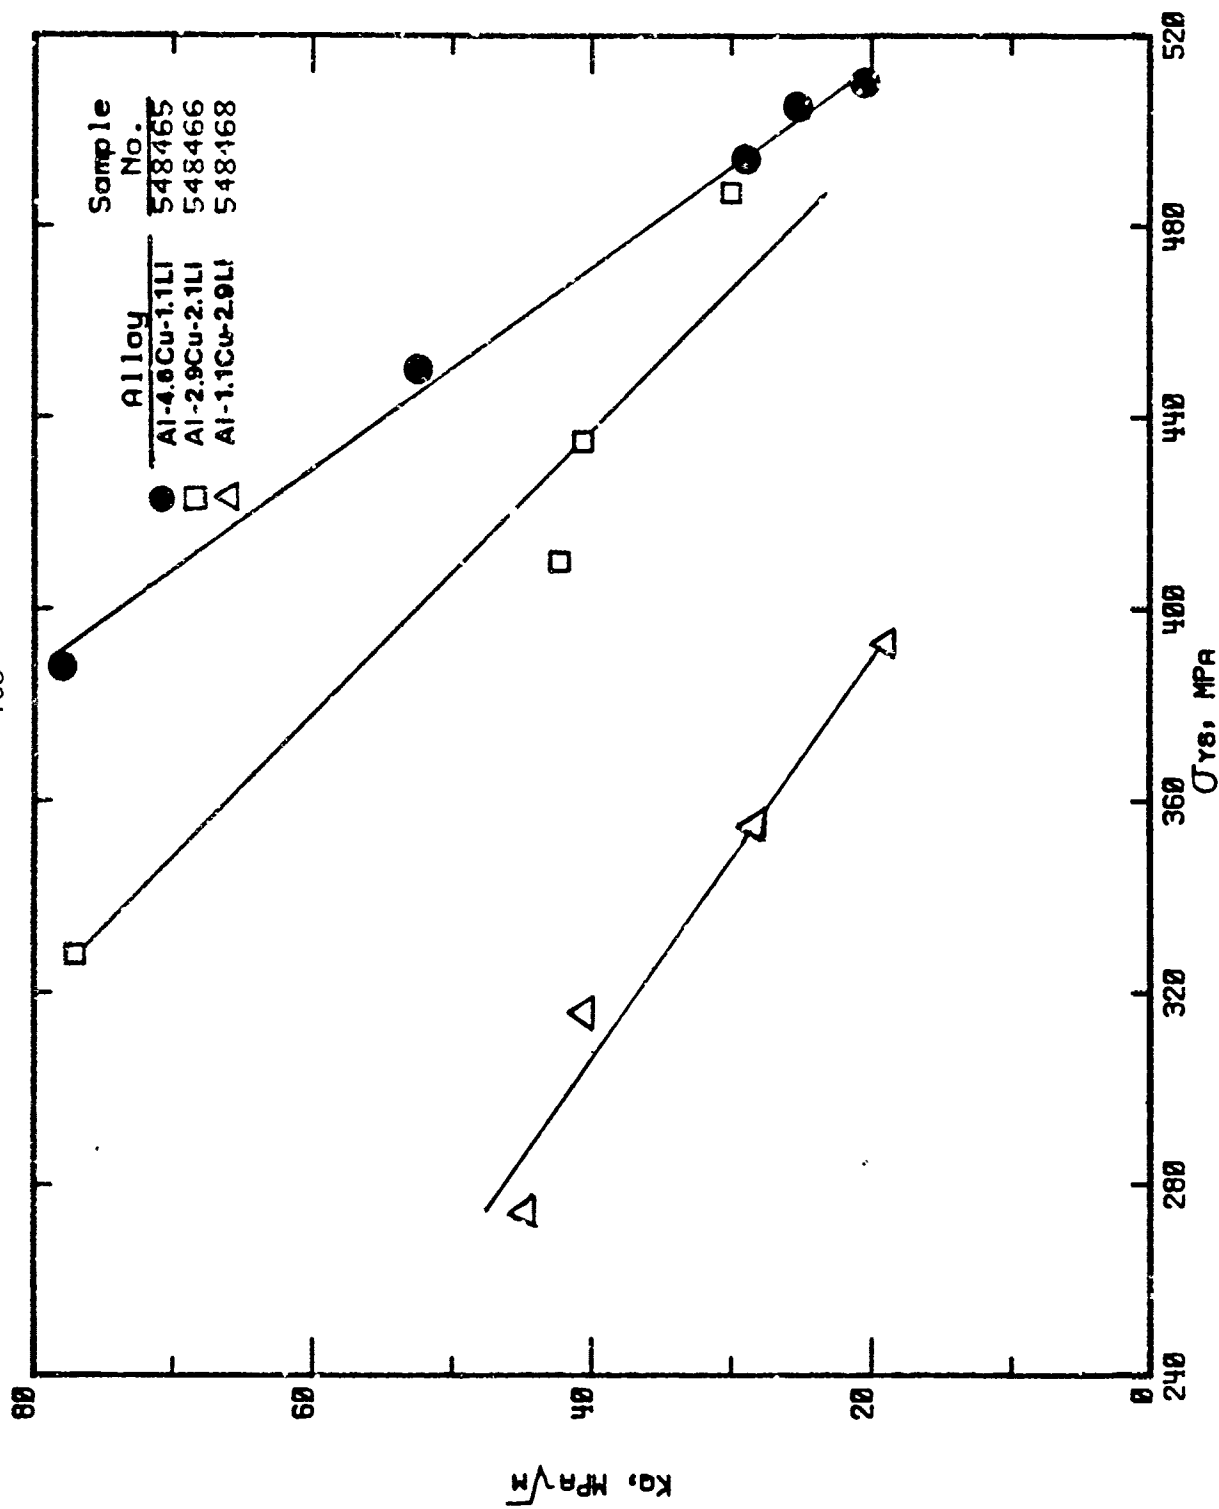
EFFECT OF CU AND LI CONTENT VARIATIONS ON THE  
FRACTURE TOUGHNESS ( $K_0$ ) VERSUS TENSILE YIELD STRENGTH ( $\sigma_{ys}$ ) OF  
THREE AL-LI ALLOY SAMPLES (548465, 548466, 548468)

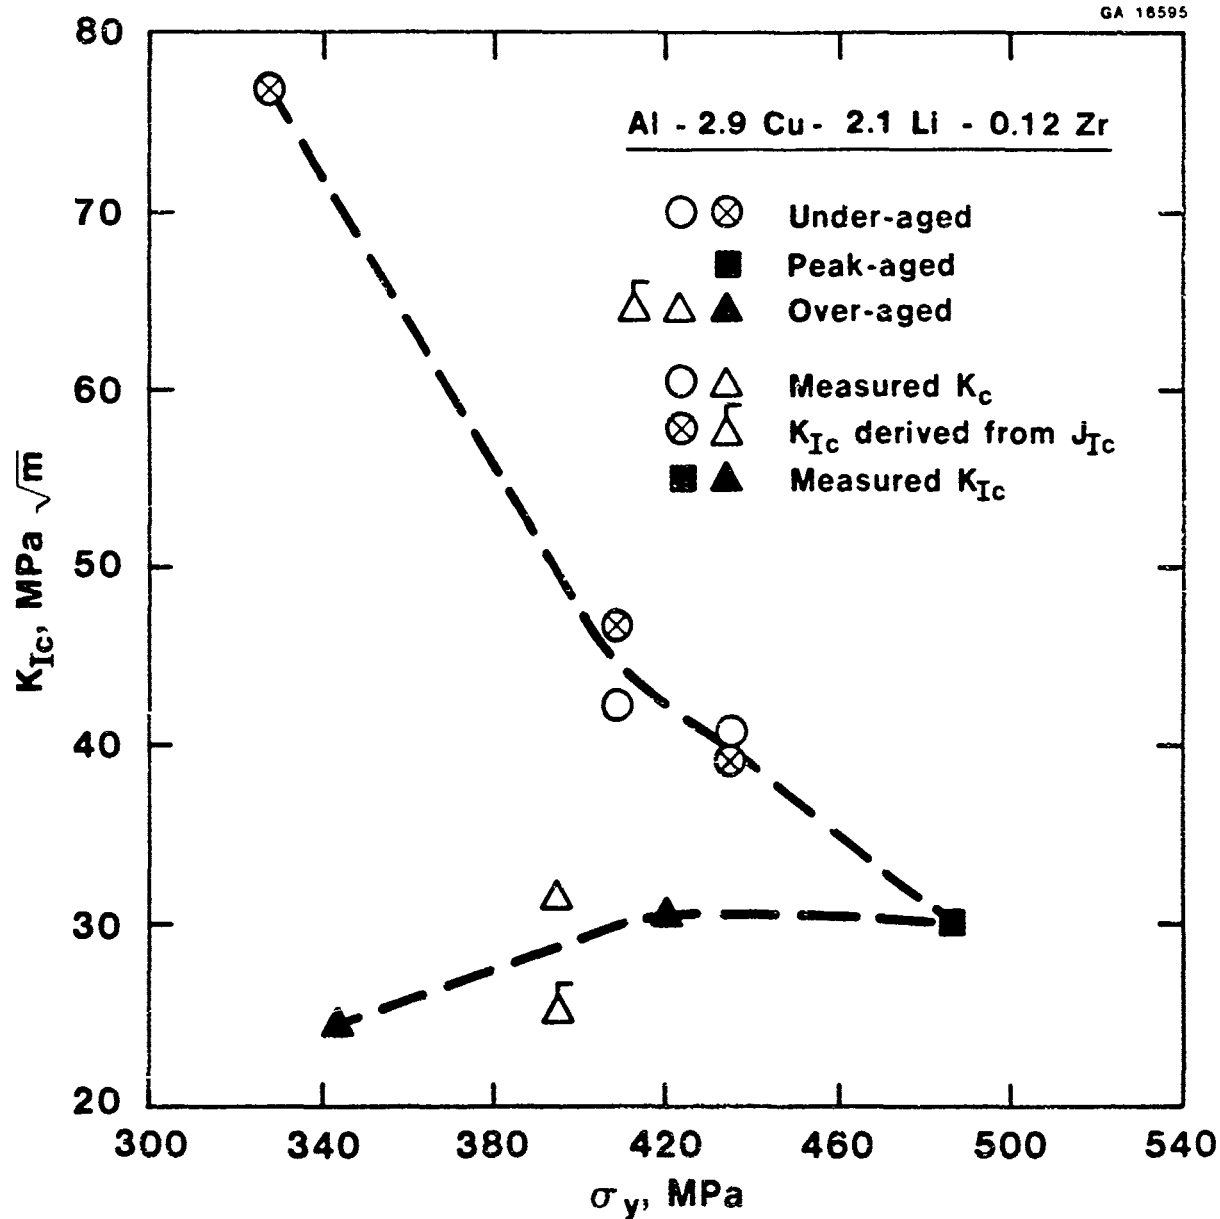
Figure 57

**Variation of Nominal Mode I Fracture Toughness,  $K_{Ic}$ , with Tensile Yield Strength,  $\sigma_y$ , for the Microstructures Investigated.**

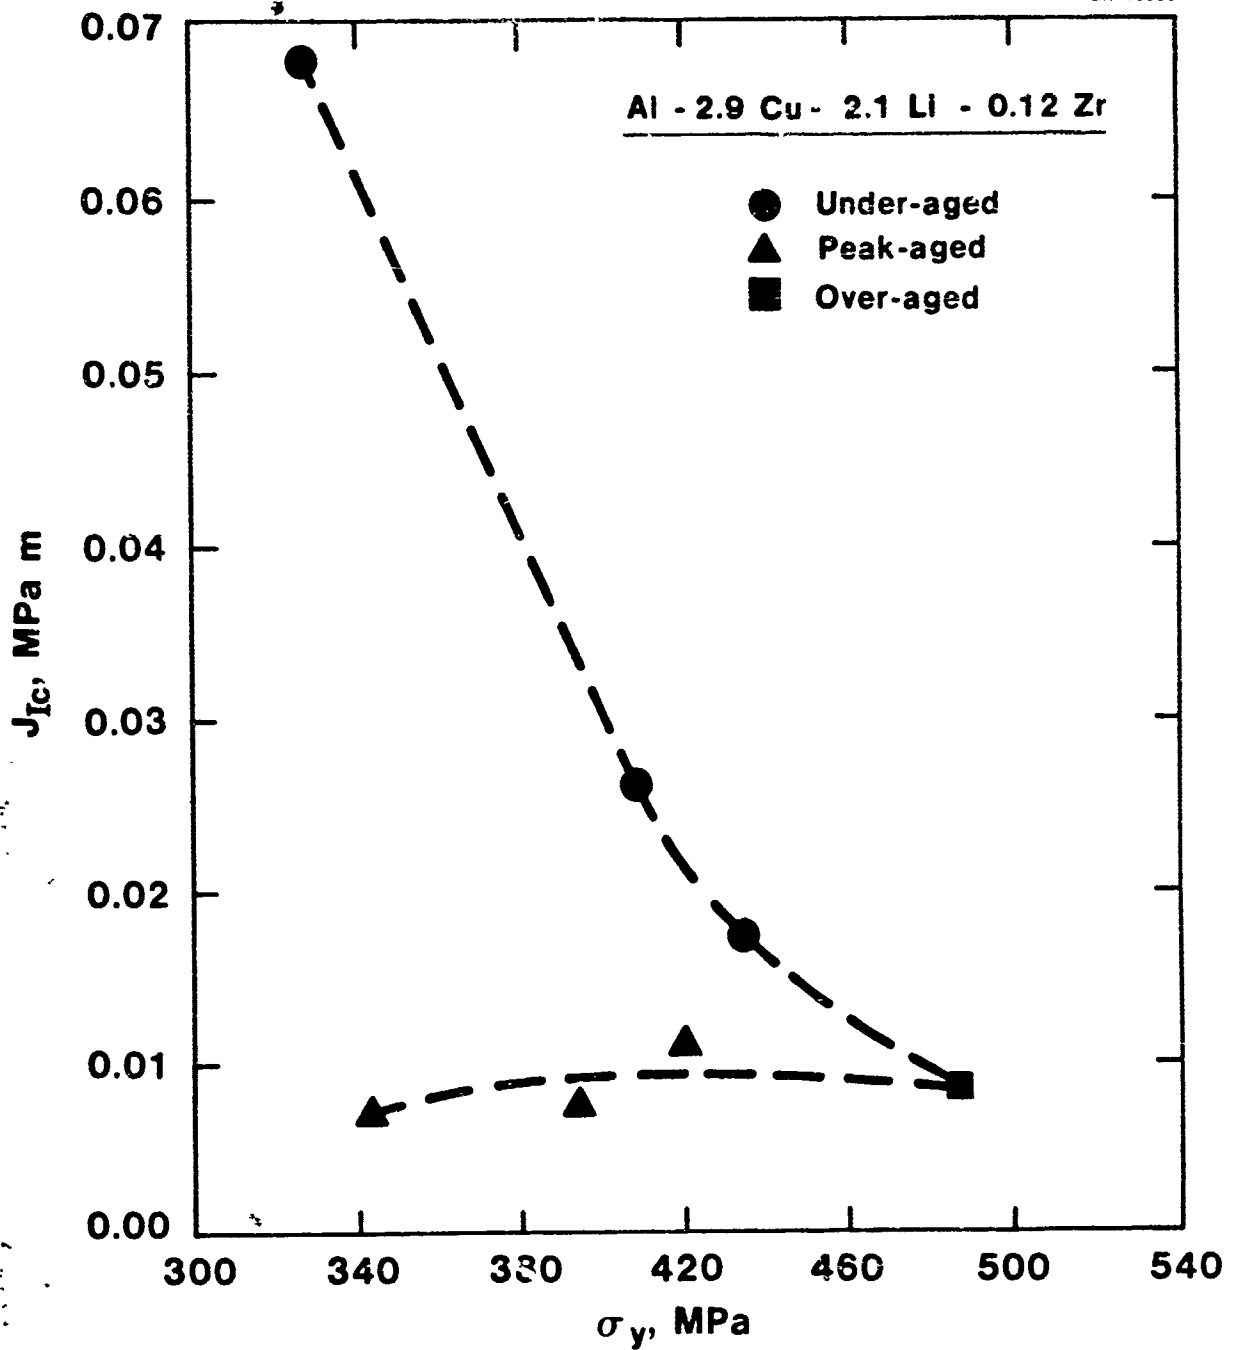
Figure 58

**Variation of Nominal Elastic-Plastic Fracture Toughness,  $J_{Ic}$ , with Tensile Yield Strength,  $\sigma_y$ , for the Microstructures Investigated.**

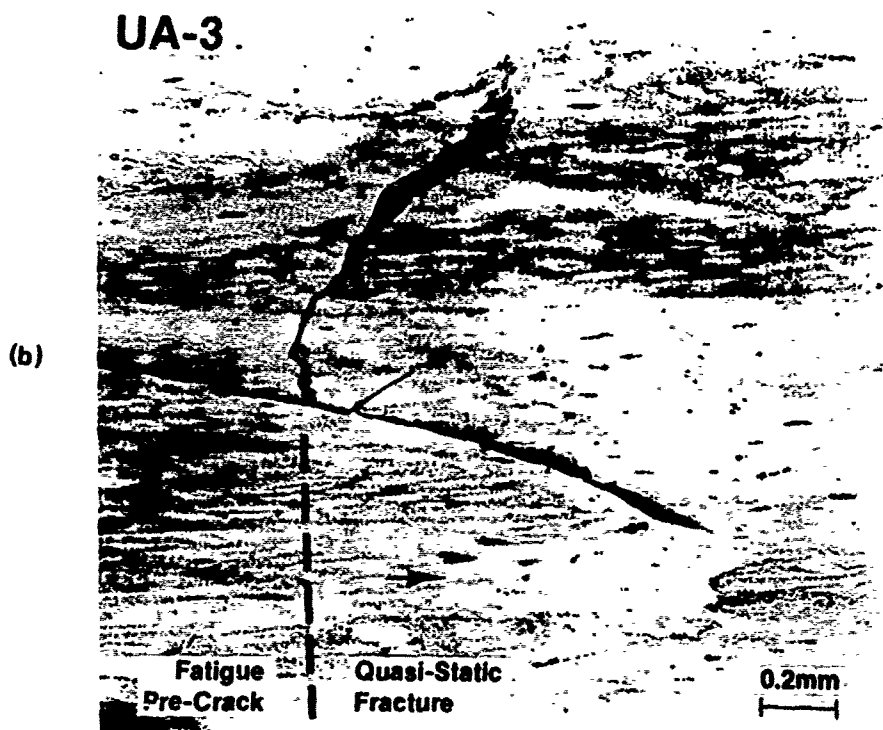
Figure 59

Crack profiles observed on the surfaces of 12.74 mm thick fracture test specimens from Al -2.9Cu -2.1Li alloy in the UA-1 (a) and UA-3 (b) temper conditions.

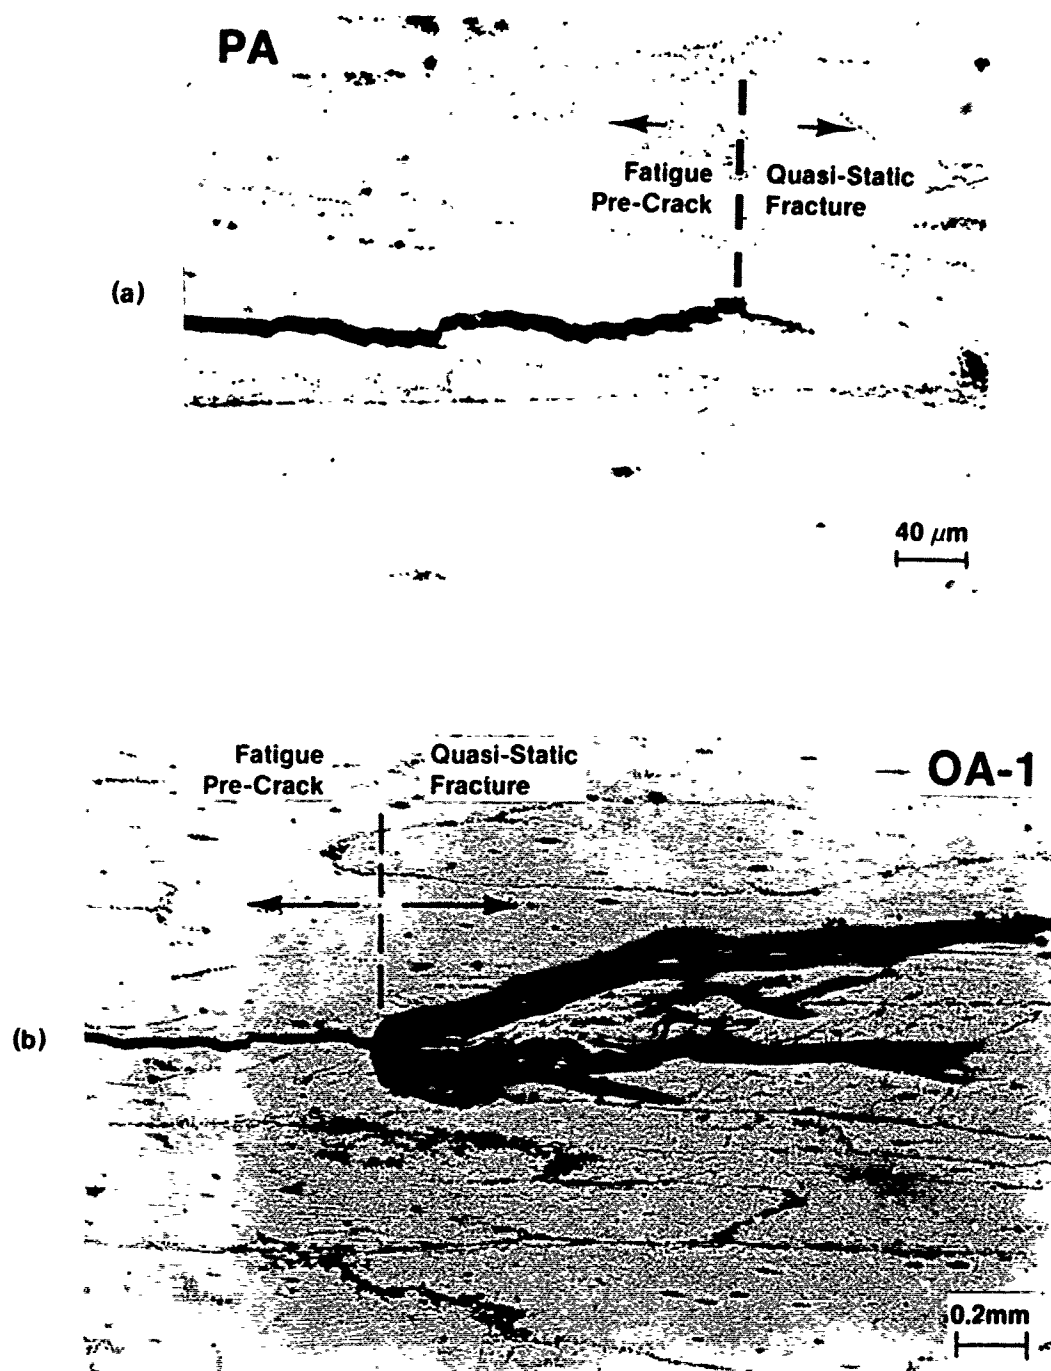
Crack profiles observed on the surfaces of 12.74 mm thick fracture test specimens from Al -2.9Cu -2.1Li alloy in the PA (a) and OA-1 (b) temper conditions. Note the shape of the plastic zone in (b).

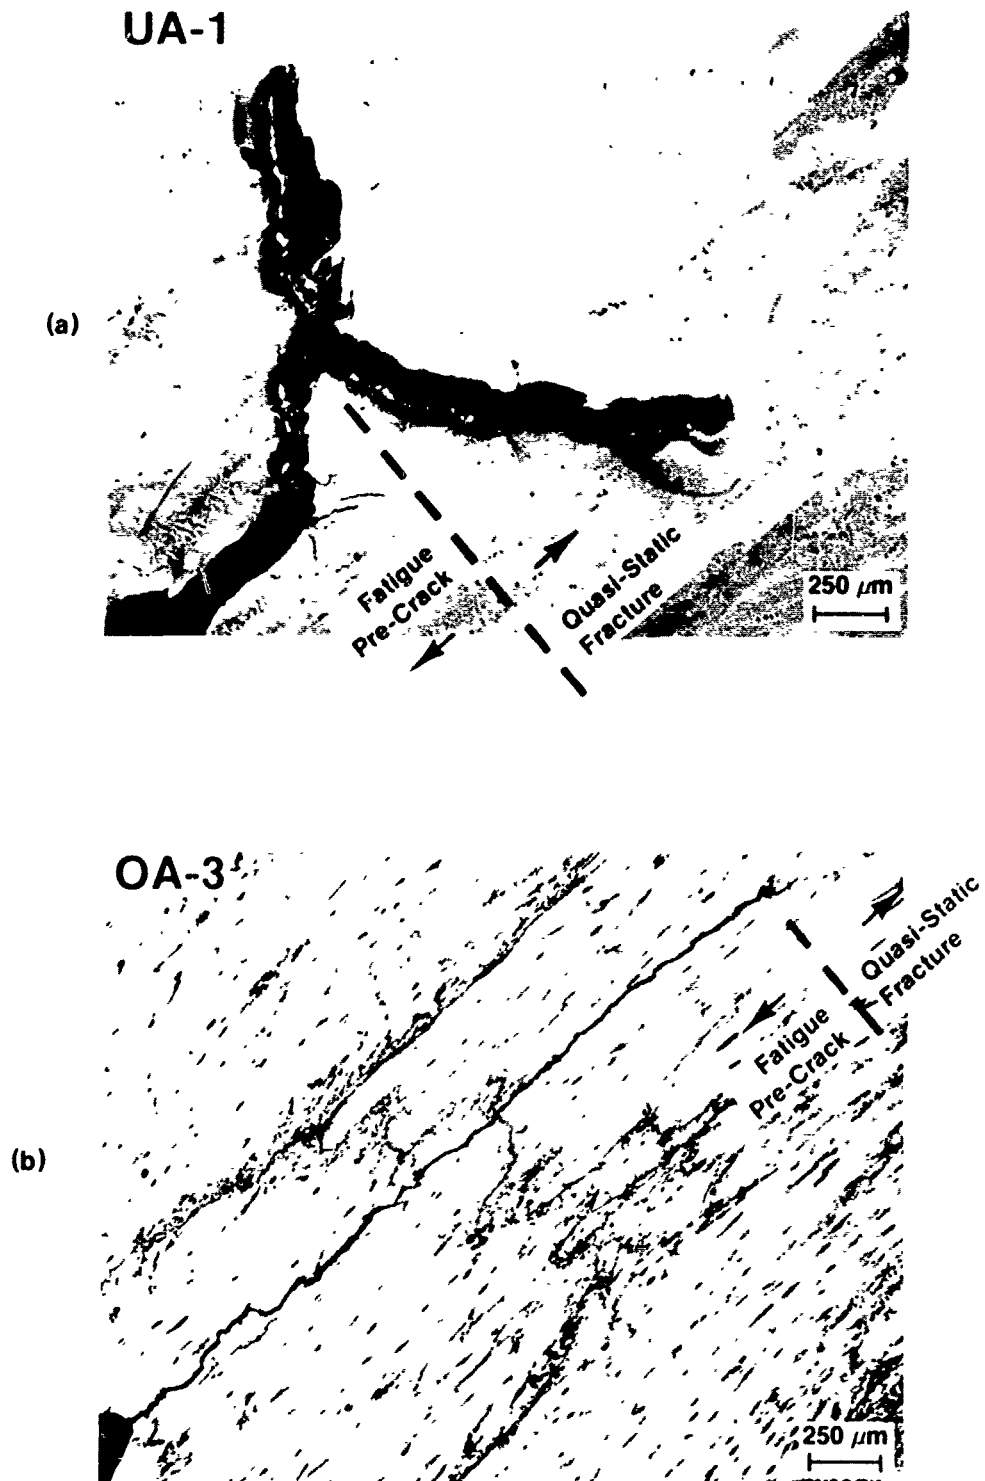
Crack profiles observed at center-thickness sections (6.37 mm from the surface) of 12.74 mm thick fracture test specimens from Al -2.9Cu -2.1Li alloy in the UA-1 (a) and OA-3 (b) temper conditions.

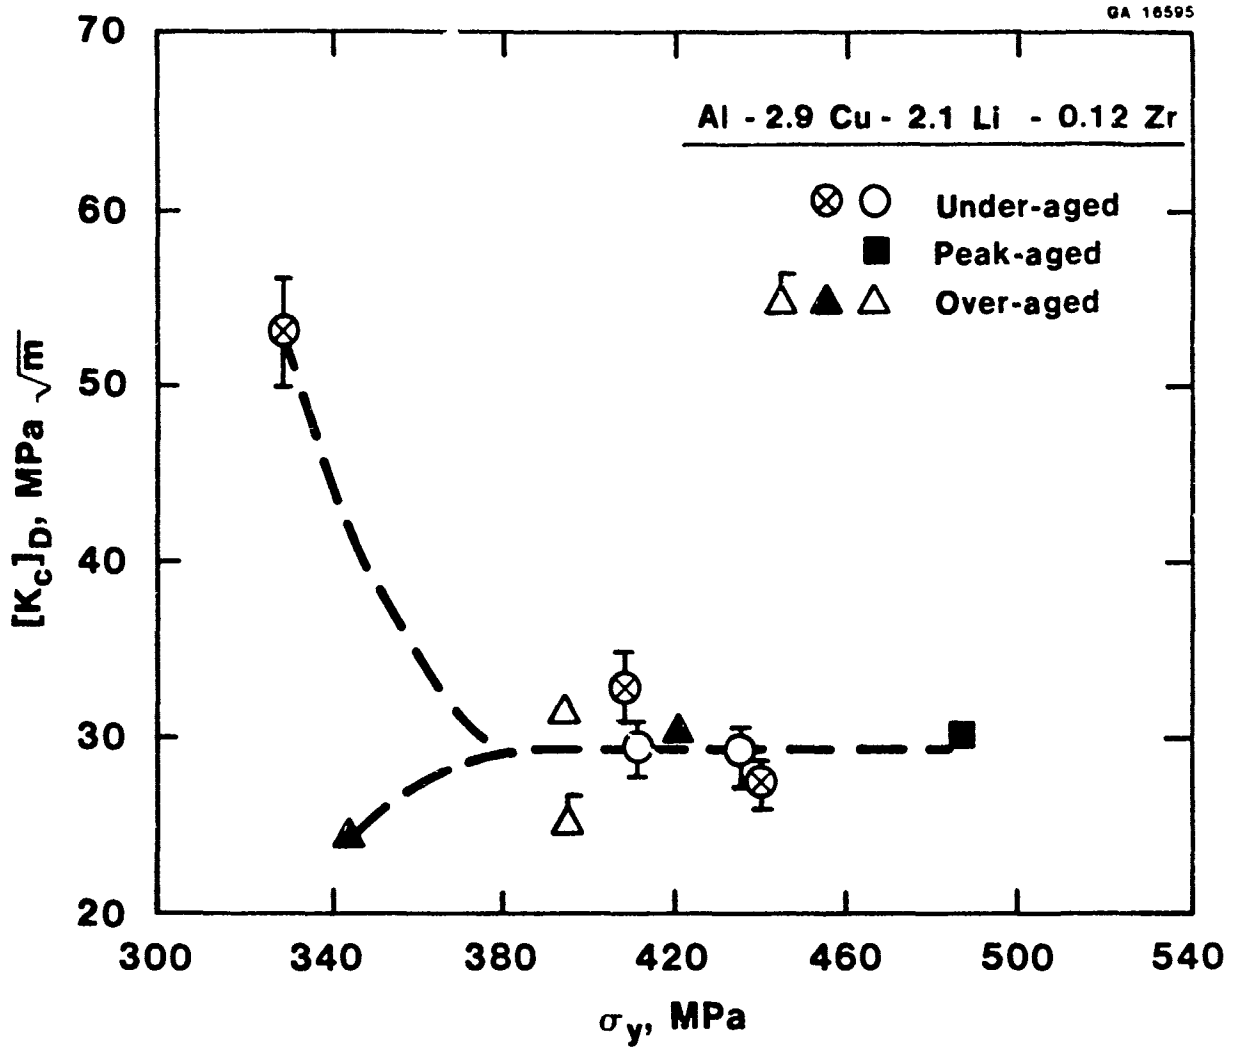
**Variation of Deflection-Modified Fracture Toughness,  $[K_c]_D$ , with Tensile Yield Strength,  $\sigma_y$ , for the Microstructures Investigated**

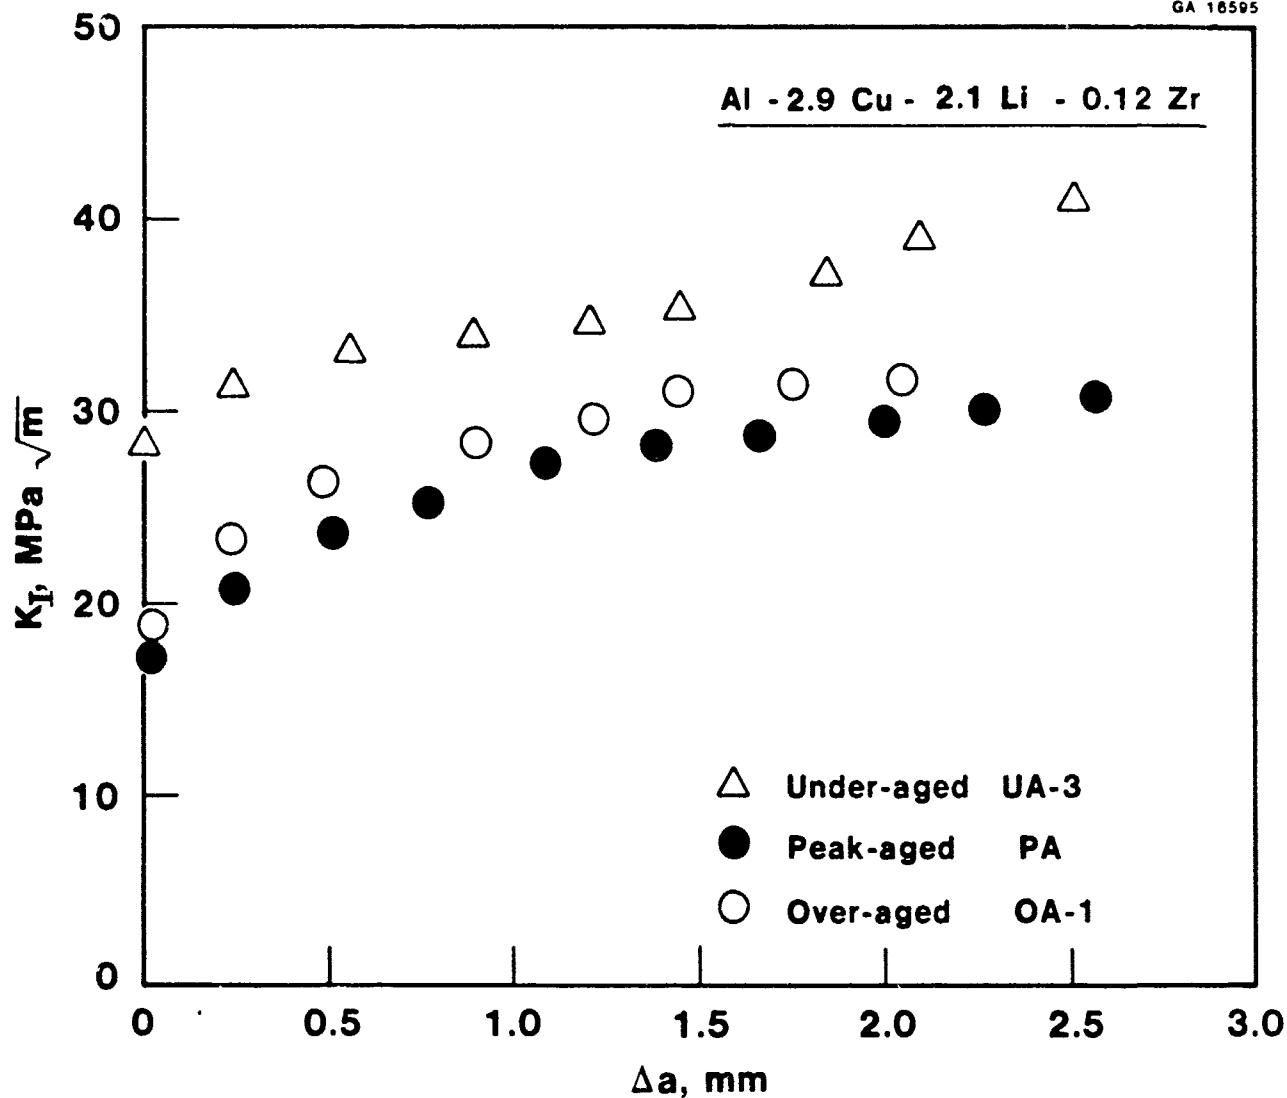
Figure 65

**Variation of Nominal Mode I Stress-Intensity Factor,  $K_I$ , with Change in Crack Length,  $\Delta a$ , (R-Curve) for UA-3, PA and OA-1 Tempers.**
